## HISTORIC CULTURAL HERITAGE SURVEY

### PROPOSED MILL SITE BIG BAY AND LONG REACH ALLOTMENTS

#### FINAL REPORT

Prepared by Parry Kostoglou  
For Gunns Limited.  
April, 2005.

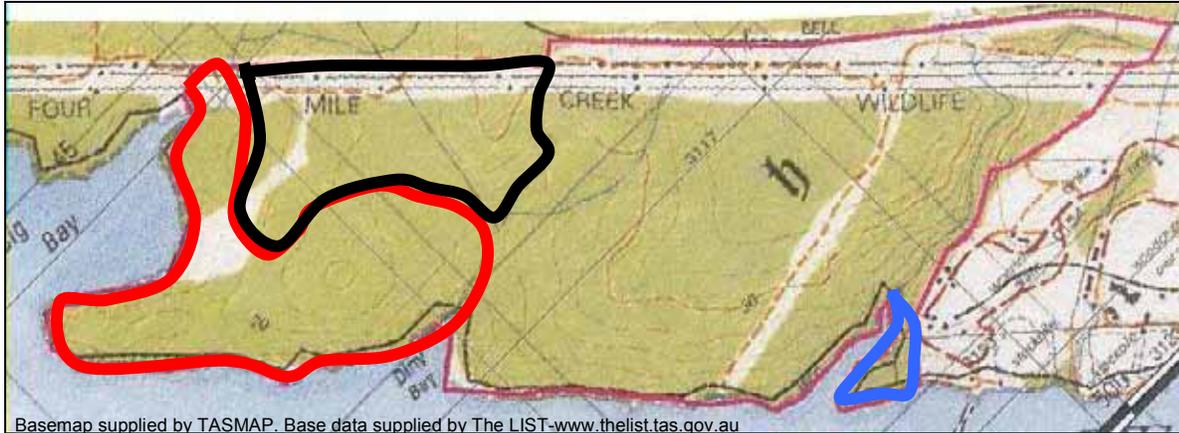
This section seeks to quantify the potential for further unknown historic sites to be situated within the subject allotment.

- High potential**
- Medium potential**
- Low potential**

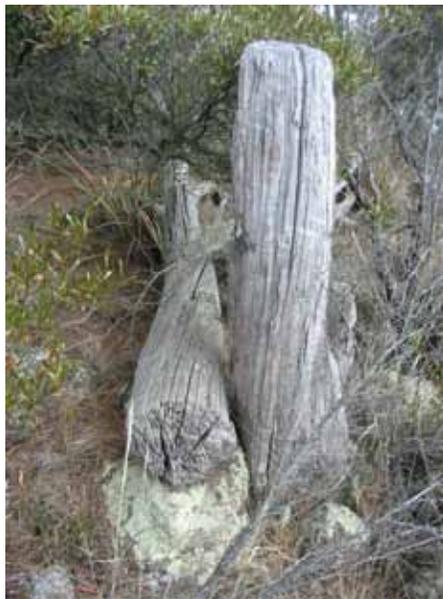
| <b>Description of remains:</b> 1.25 metre high <i>in situ</i> tree stump and remainder of felled log measuring five metres in length lying adjacent. The felled log has a second axe cut face evident on one aspect. | | | |
| <b>Interpretation of site:</b> Tree felled for use by mid 19 <sup>th</sup> century occupants of nearby riverside hut site. | | | |

**Photo showing axe felled tree at base of stump.**

| <b>Recommendations:</b> None made | | | |

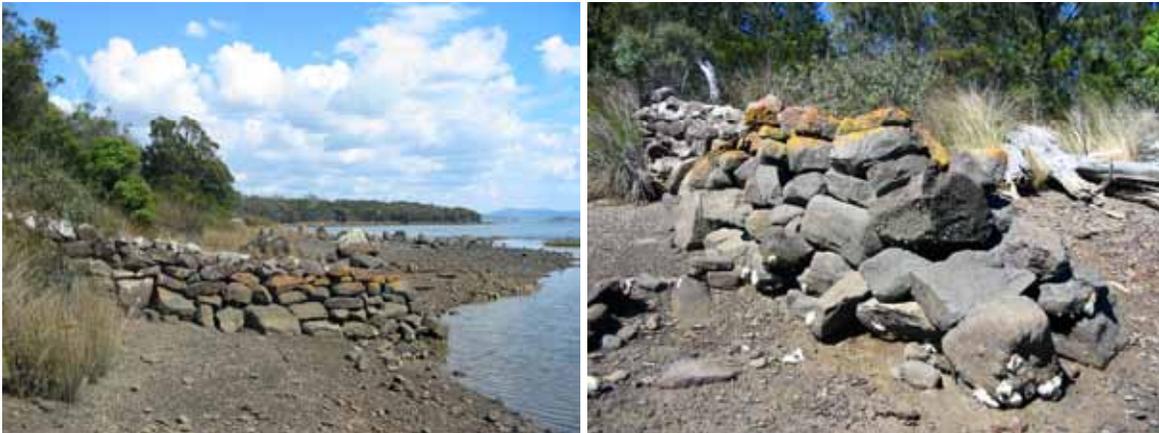
| <b>Description of remains:</b> Sea side dry stone wall erected near mouth of creek. Wall measures 8.5 x 1 x 1.5 metres in height and consists of assorted ashlar and block shaped stone work to 350mm in length/diameter. There are no known nearby associated features or artefacts. | | | |
| <b>Interpretation of site:</b> Given the absence of associated occupational features or artefacts, this feature was most likely erected as a boundary marker. | | | |

**Photo showing general and detail views of sea side stone wall.**

| <b>Recommendations:</b> Protection from all impacts required. | | | |

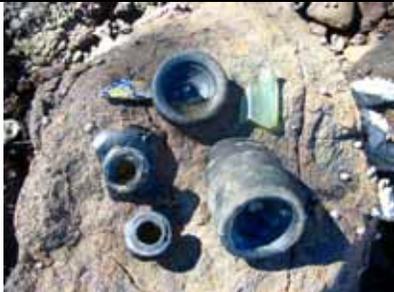
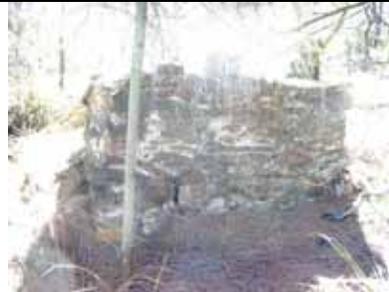
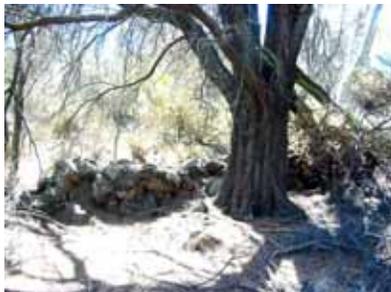
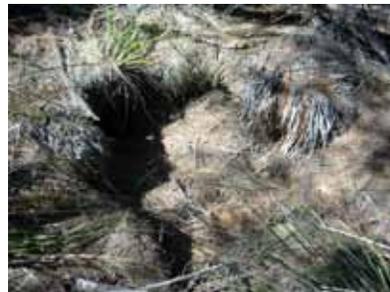
| <p><b>Description of remains:</b> This site consists of four riverside features situated in regrowth open woodland.</p> <ul style="list-style-type: none"> <li>■ <u>Stone chimney/foundation</u><br/>A lime mortared stone chimney measuring 1900 x 1500 x 1200mm high. The feature's internal fireplace faces northerly onto a larger 10 x 7 metre stone lined rectangular building footing.</li> <li>■ <u>Stone wall</u><br/>A 7 x 0.5 x 1 metre high dry-stone wall lies five metres north westerly of the chimney.</li> <li>■ <u>Excavation</u><br/>A rectangular shaped pit measuring 1750 x 1250 x 400mm in depth was noted 23 metres south of the chimney feature.</li> <li>■ <u>Artefact scatter</u><br/>Several small assorted fabric artefacts were noted on the foreshore west of the house site including case gin bottle fragments, clear glass medicinal bottle fragments and blue transfer ware plate fragments.</li> </ul> | | | |
| <b>Interpretation of site:</b> Mid 19 <sup>th</sup> century riverside occupation site. | | | |

**Photos showing waterside artefacts, hut chimney, adjacent wall and excavation.**

| <b>Recommendations:</b> Protection from all impacts required. | | | |

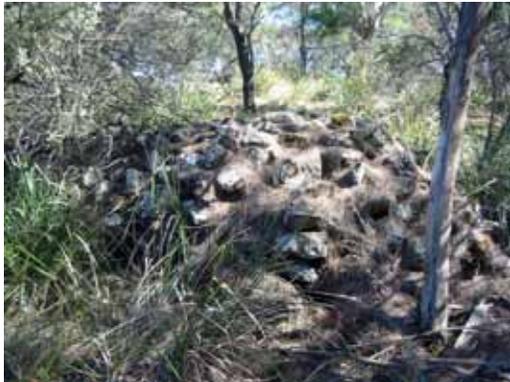
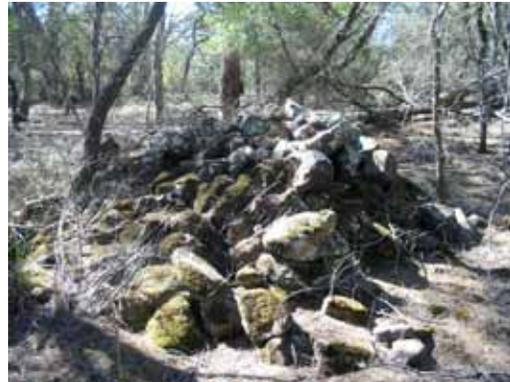
| <b>Description of remains:</b> This forty metre squared area containing at least thirteen stone piles is situated immediately north east/uphill of Big Bay house site 1 (Site 03). These piles measure up to 3 x 2 x 1.5 metres in height and consist entirely of locally collected material. | | | |
| <b>Interpretation of site:</b> Agricultural land clearance residues. | | | |

**Photos showing random stone piles most probably resulting from agriculturally related land clearance.**

| <b>Recommendations:</b> Protection in association with adjacent house site required. | | | |

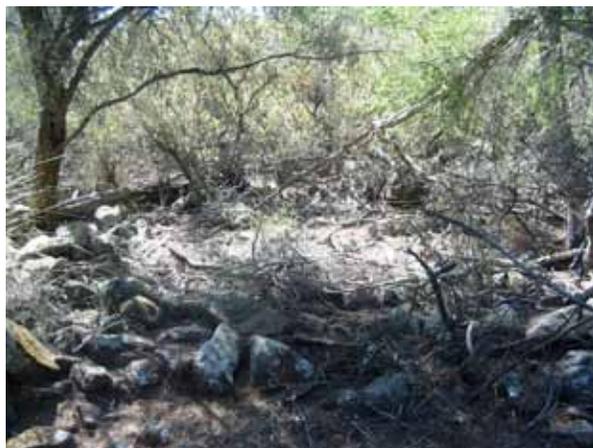
| <b>Description of remains:</b> Three metre diameter stone circle forming part of a stone fence line. Only twenty remnant metres of linear fence line could be traced on either side of the circle. | | |
| <b>Interpretation of site:</b> Unknown functional feature associated with fence (animal corral or tree bed?). | | |

**Photo showing stone circle associated with Big Bay House site 1.**

| <b>Recommendations:</b> Protection in association with nearby house site required. | | |

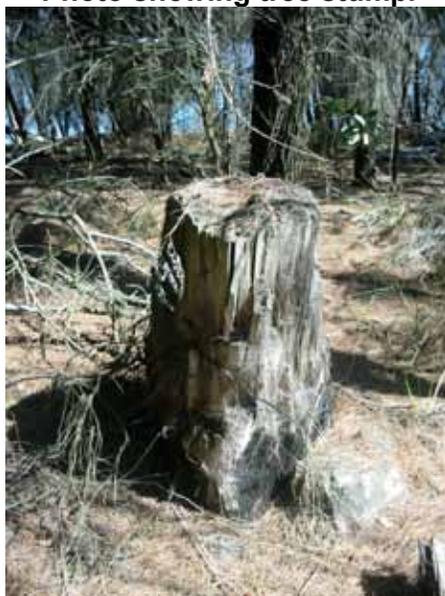
**Photo showing tree stump.**

| <b>Recommendations:</b> None made. | | | |

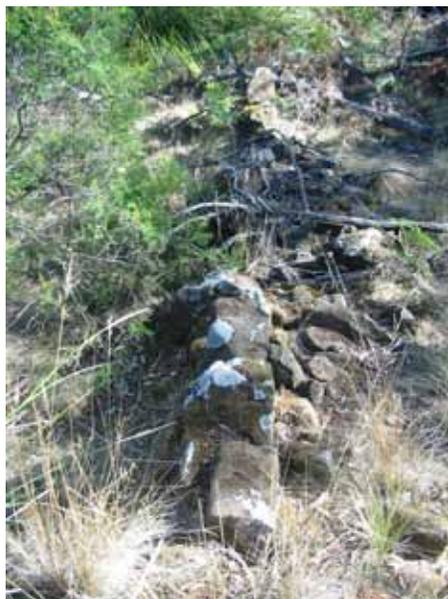
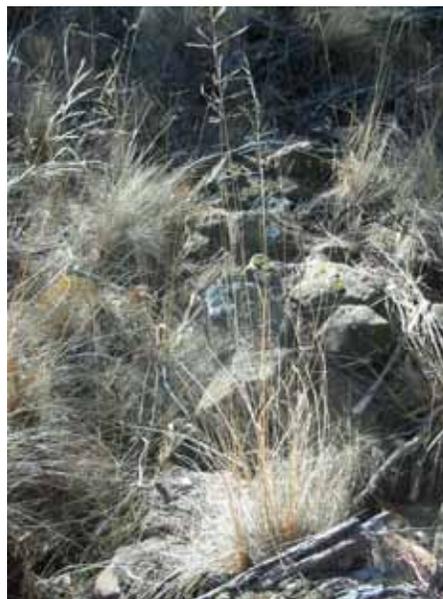
**Photos showing remnant wall section apparently associated with Dirty Bay house footing (Site 07).**

| <b>Recommendations:</b> Protection in association with nearby house site required. | | | |

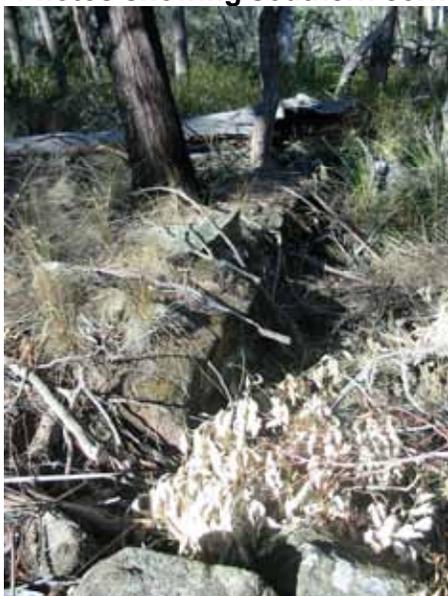
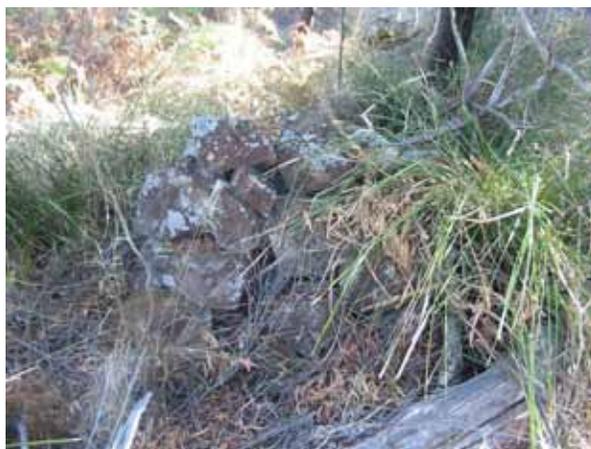
**Description of remains:**
**Interpretation of site:** Unknown building location. As no chimney was found, it remains uncertain whether this site was an occupational centre at Dirty Bay, although it was certainly part of a substantial encampment extending down to the waterline (see Kostoglou January, 2005).

**Photos showing southern corner of house footing and adjacent stone pile.**

**Recommendations:** This site should be protected in association with the nearby coastal remains at Dirty Bay

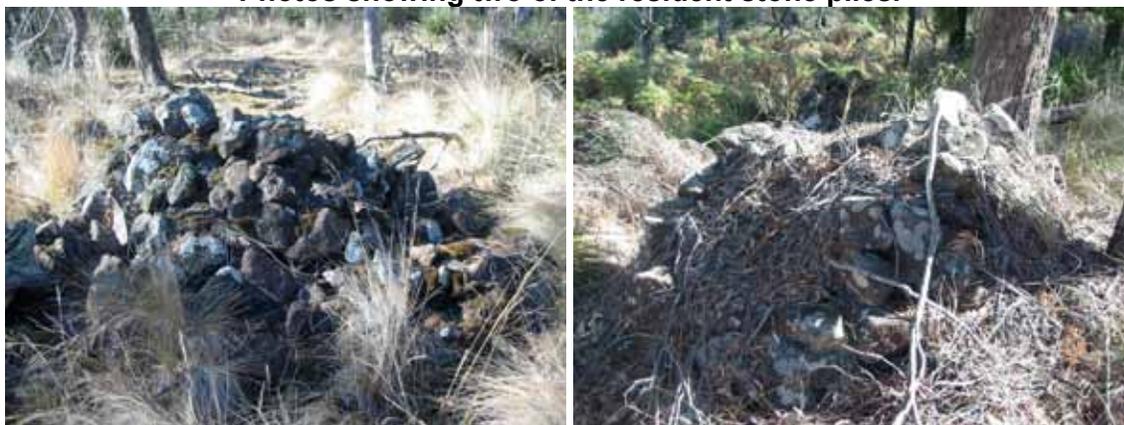
**Photos showing two of the resident stone piles.**

| <b>Recommendations:</b> Protection in association with adjacent house site required. | | | |

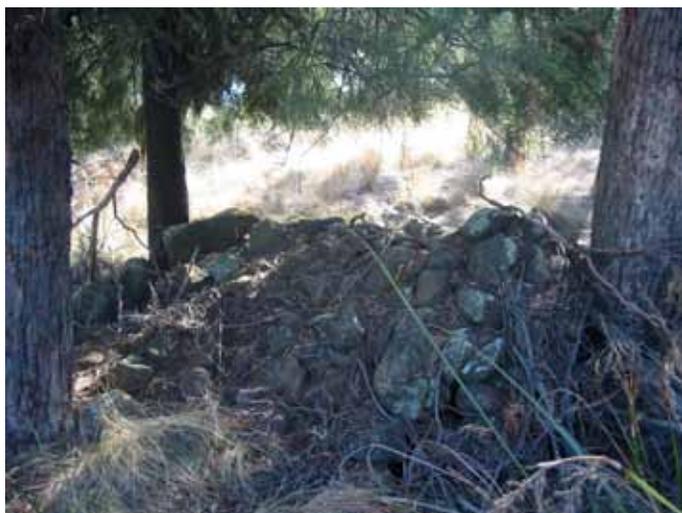
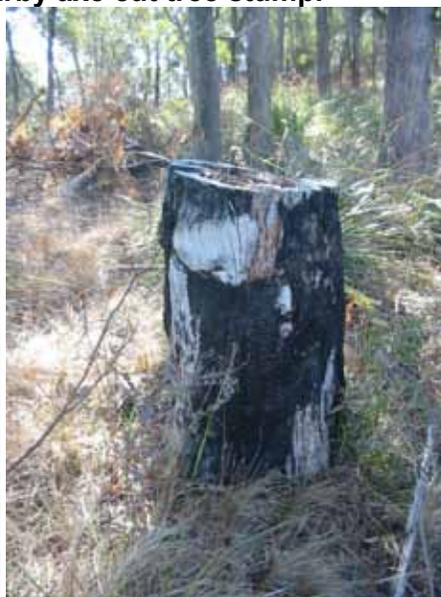
**Photos showing stone wall and nearby axe cut tree stump.**

| <b>Recommendations:</b> None made | | | |

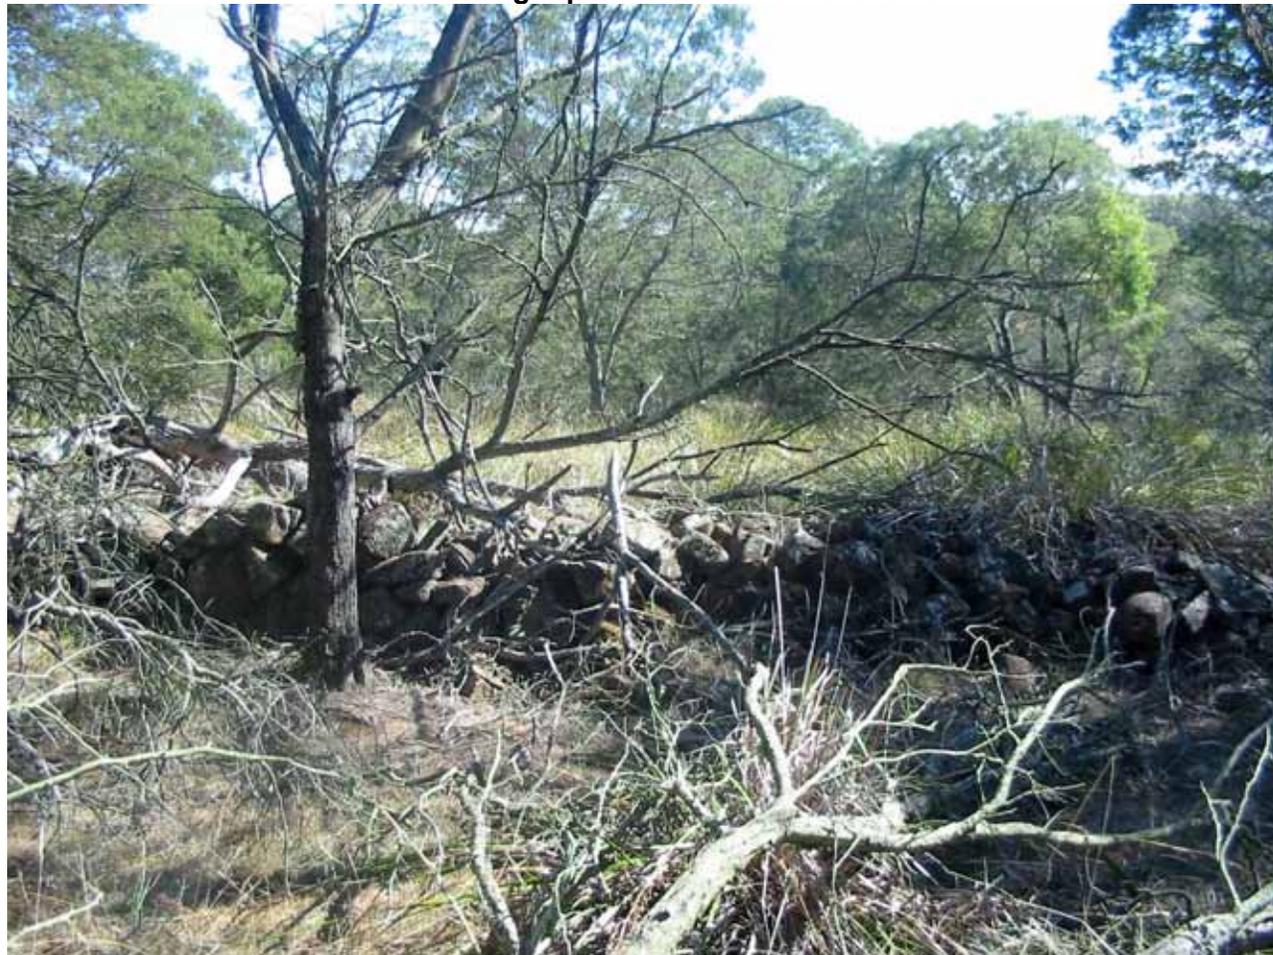
**Photo showing representative view of the wall.**

**Recommendations:** Protection from all impacts required.

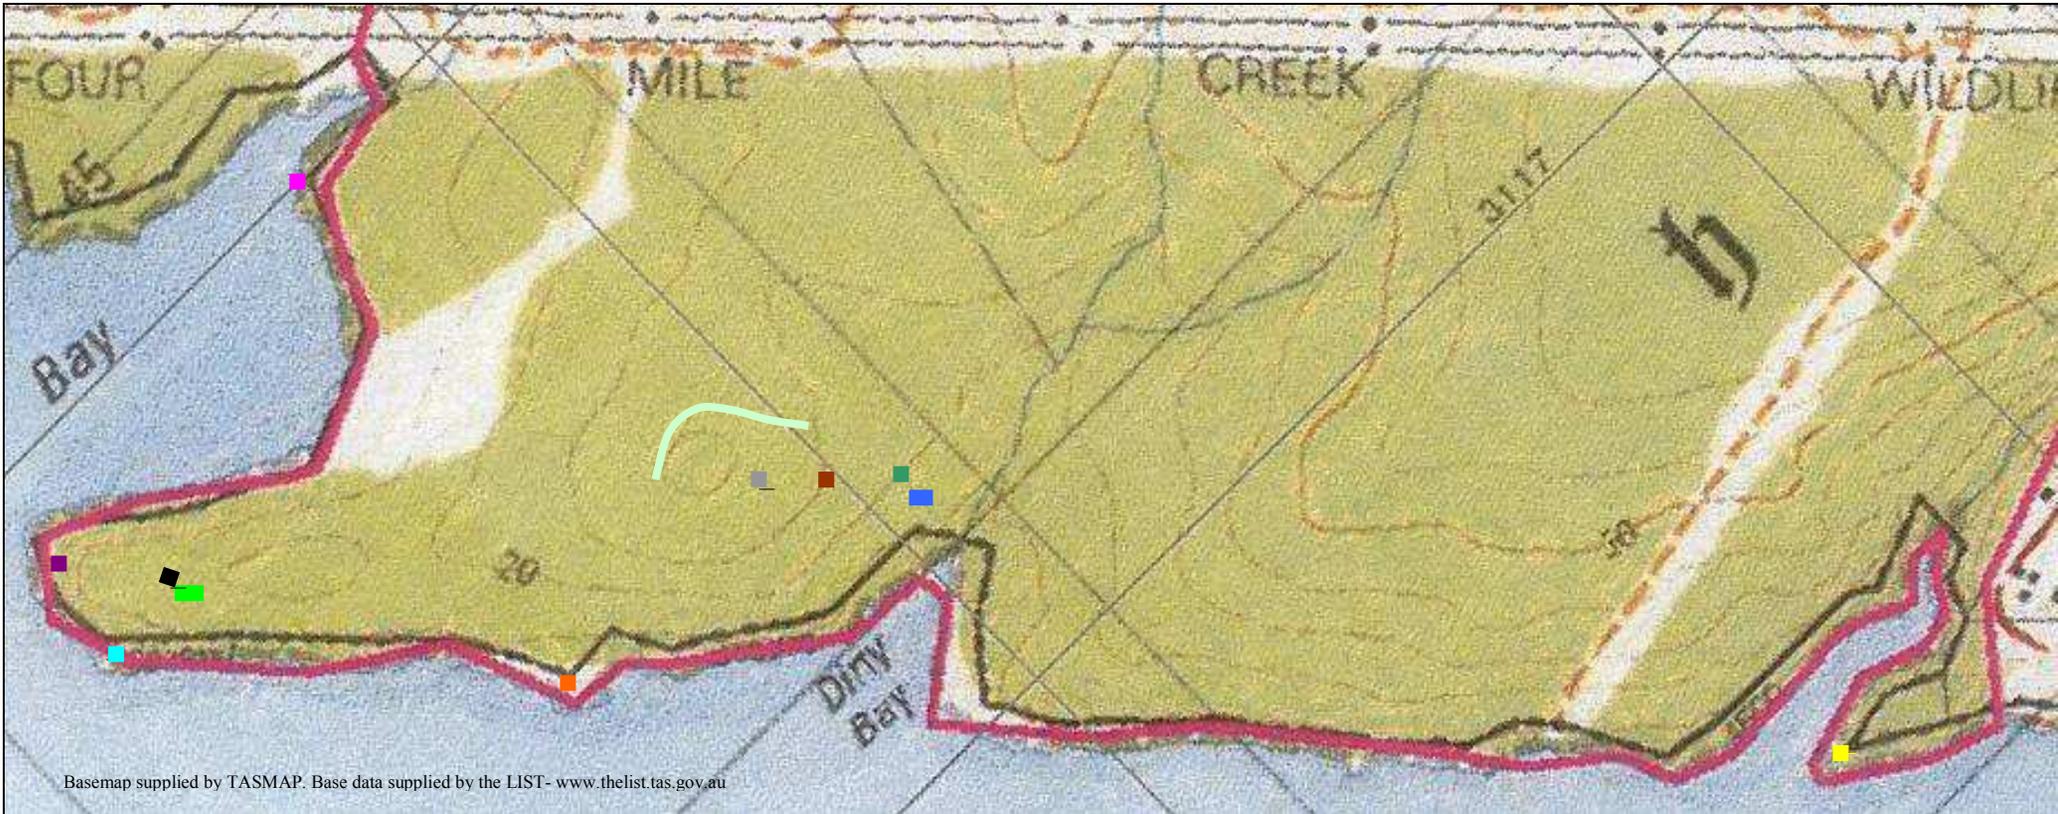
Map showing location of all sites/features identified during this assessment

| ■ Felled tree and stump (E 0493457 N 5443117) | ■ Big Bay house site 2 (E 0492519 N 5444182) |
